The further potential for undergrounding powerlines in our National Parks and the example of Glen Tromie

January 12, 2018 Nick Kempe 2 comments

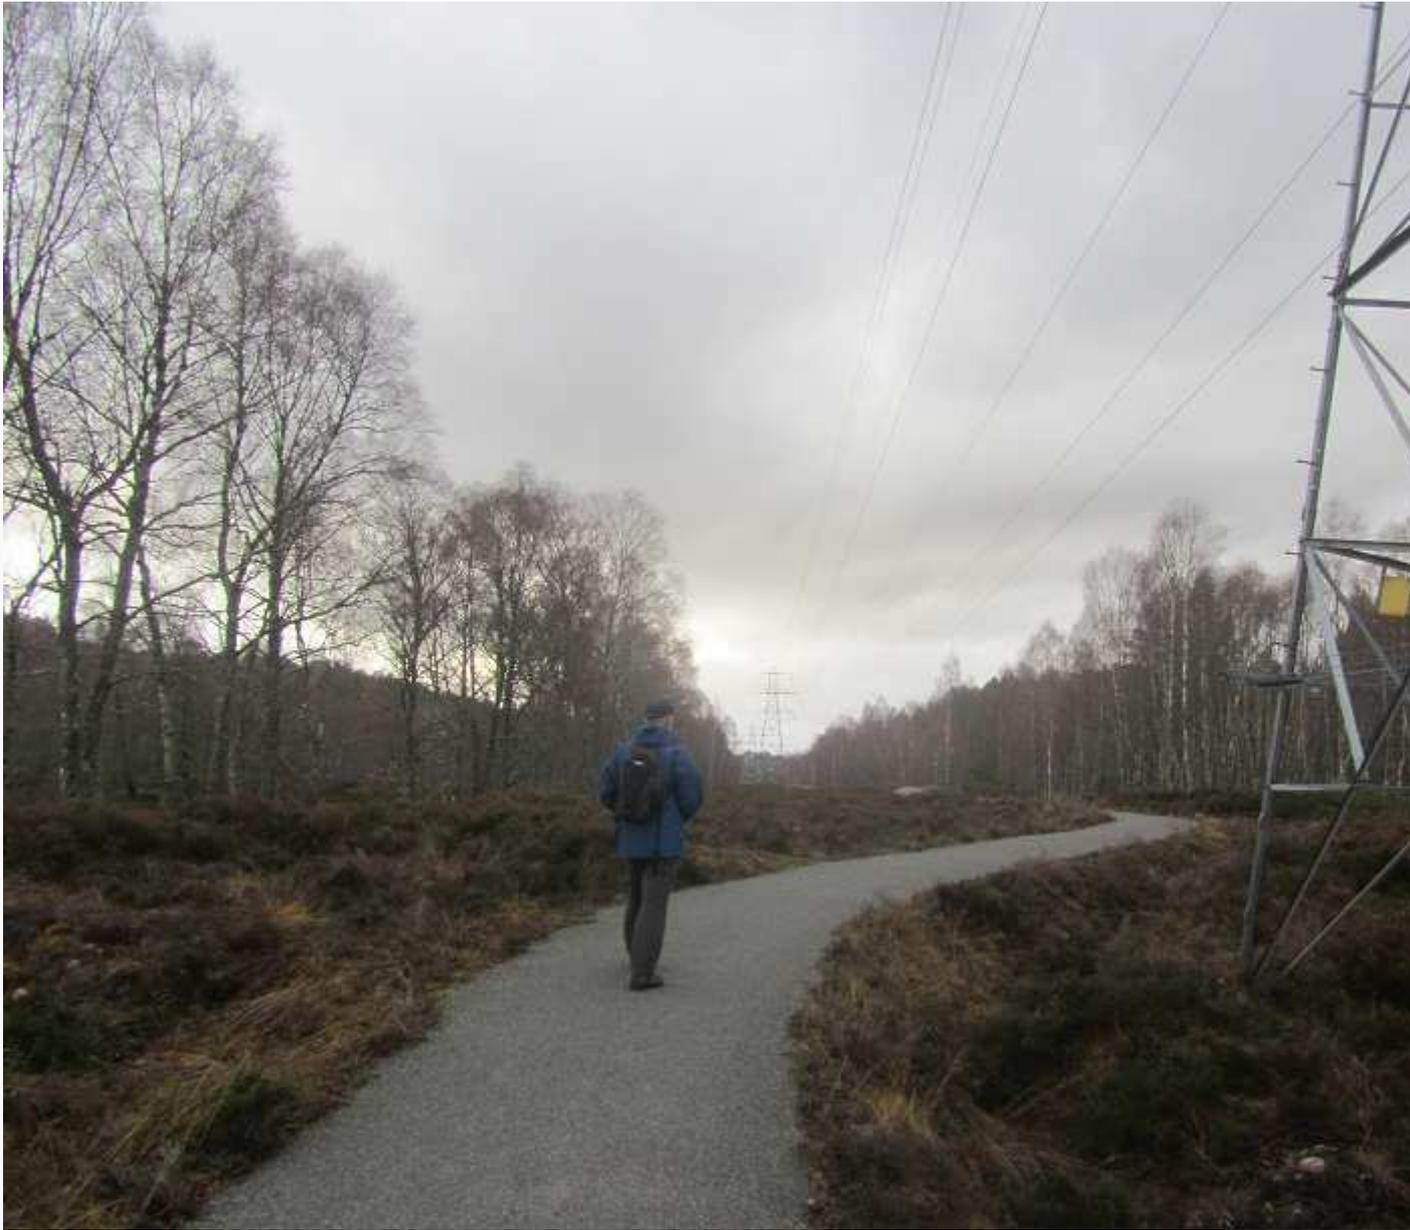
The powerlines which blighted the Speyside Way extension south of Aviemore have now been removed

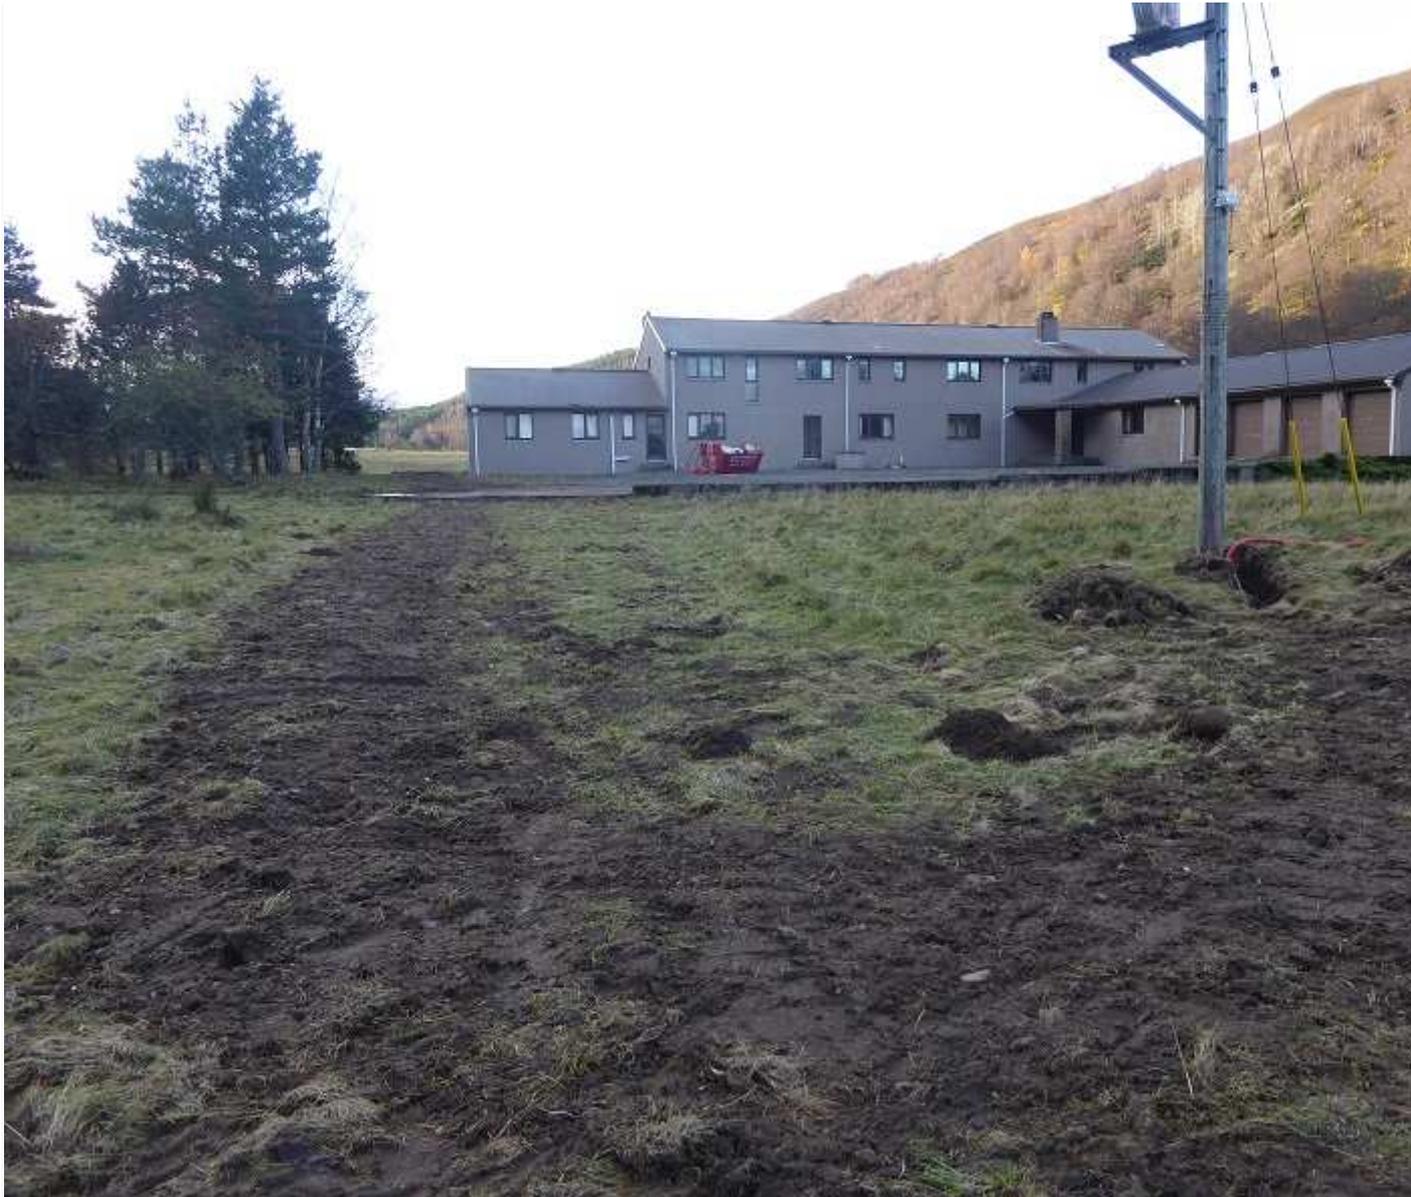
The current work to underground the Glen Tromie powerline starts at the hideous Lynaberack Lodge in Glen Tromie. The ground here, where the undergrounded line joins with the overhead powerline, is more disturbed than almost anywhere else along the route.

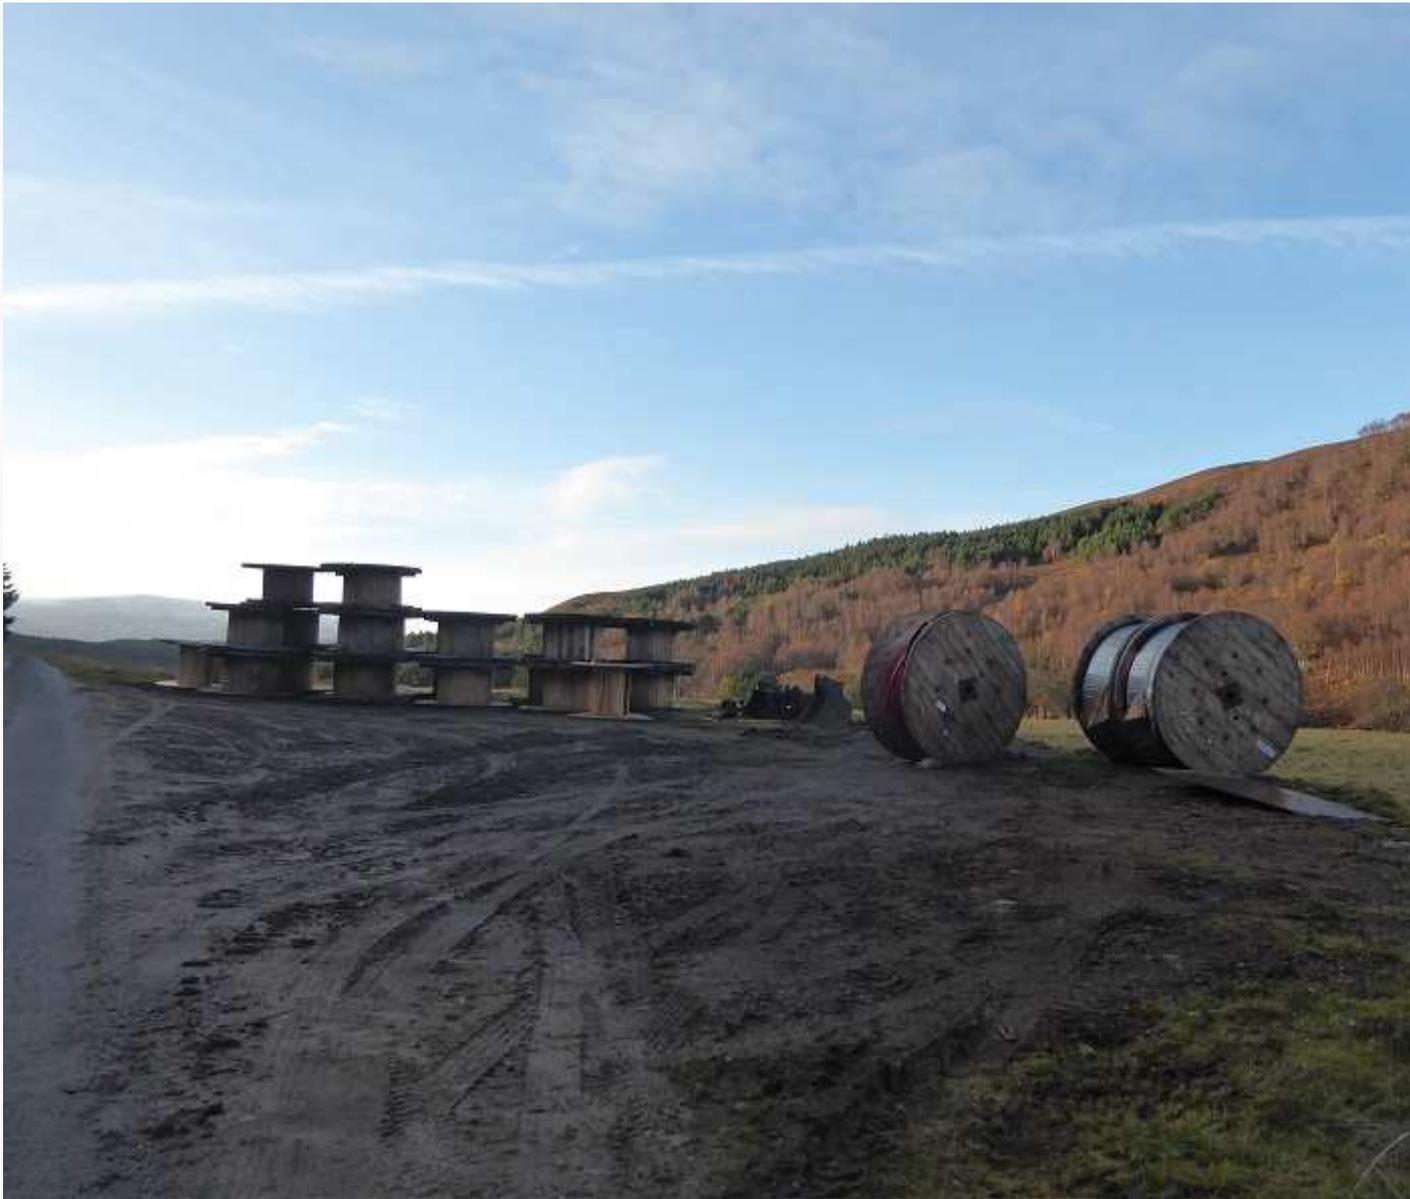
Evidence of the amount of new electric cable which has been undergrounded

The work is not yet complete. While the contractors have buried the new cable, it is not yet connected and removal of the existing powerline and clear-up has still to happen. The advantage, in terms of the timing of my visit, was I could record the landscape impact of the existing powerline.

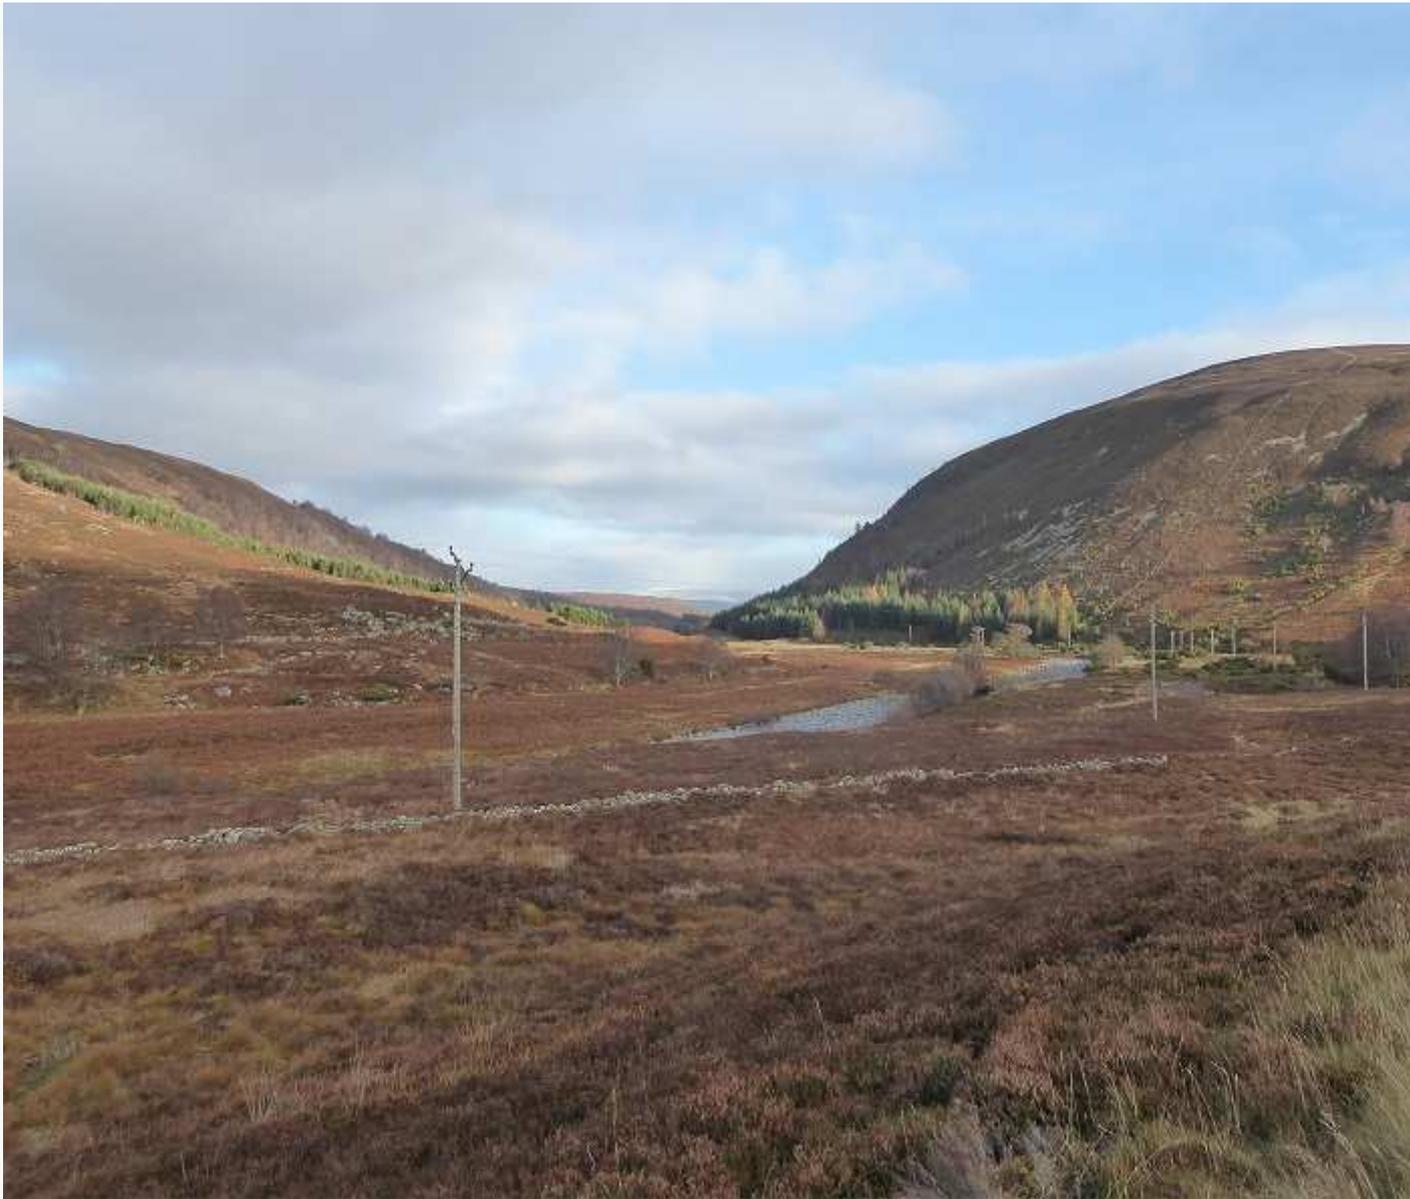
The road is just to the right of the photo

Imagine the difference, when this section of powerline is removed. While there is still a road running up the glen, to the person walking or cycling along it the view will feel significantly wilder.

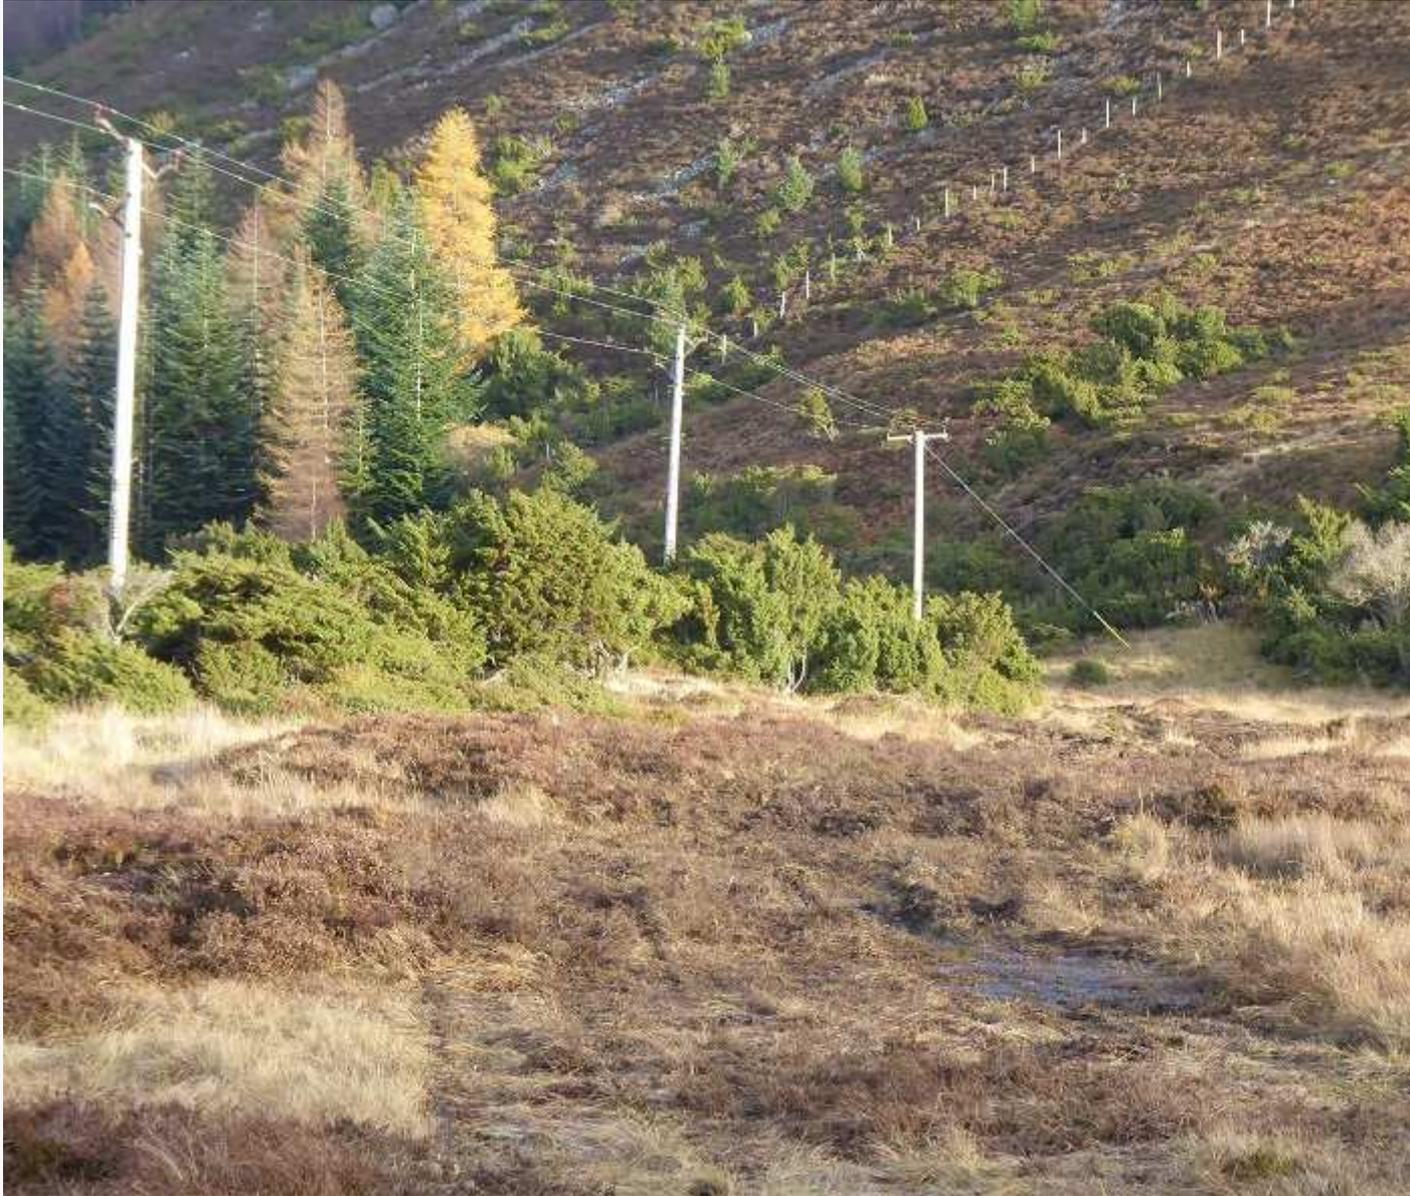
The new powerline, which lies beneath the vehicle track starting bottom centre, will replace the pylons.

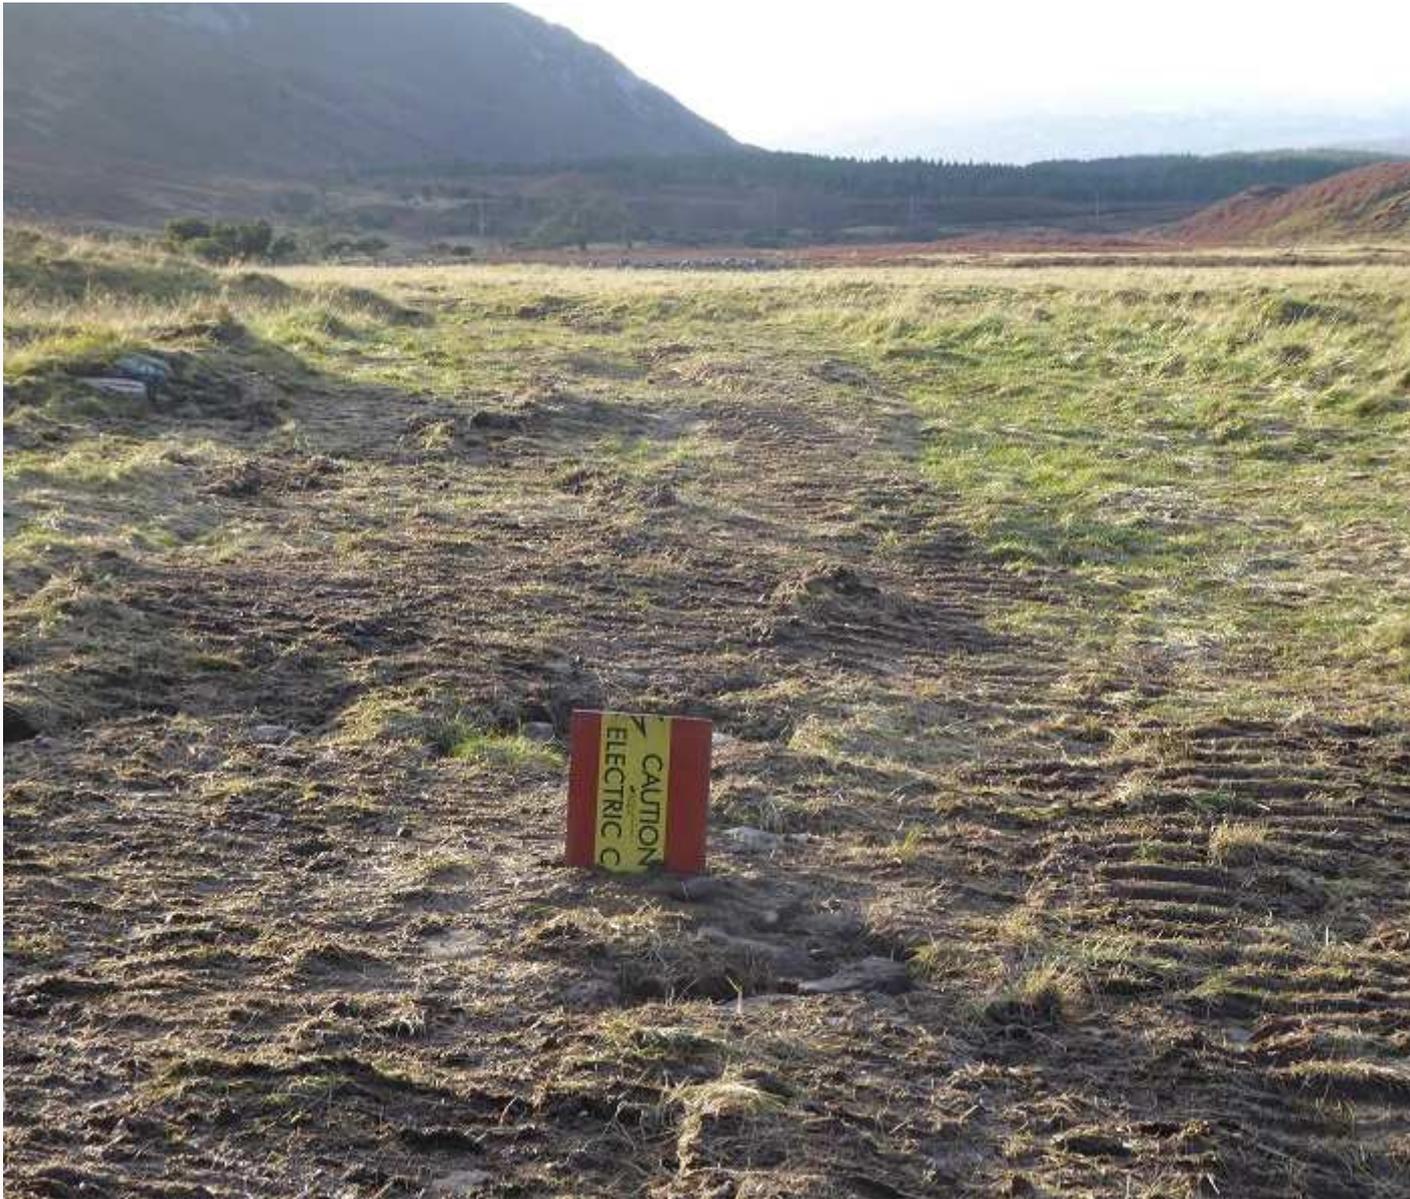
Few people would know, just a couple of week after the work had been carried out, that the reason for this ground disurbance is an electric cable had been buried unless it was for the sign

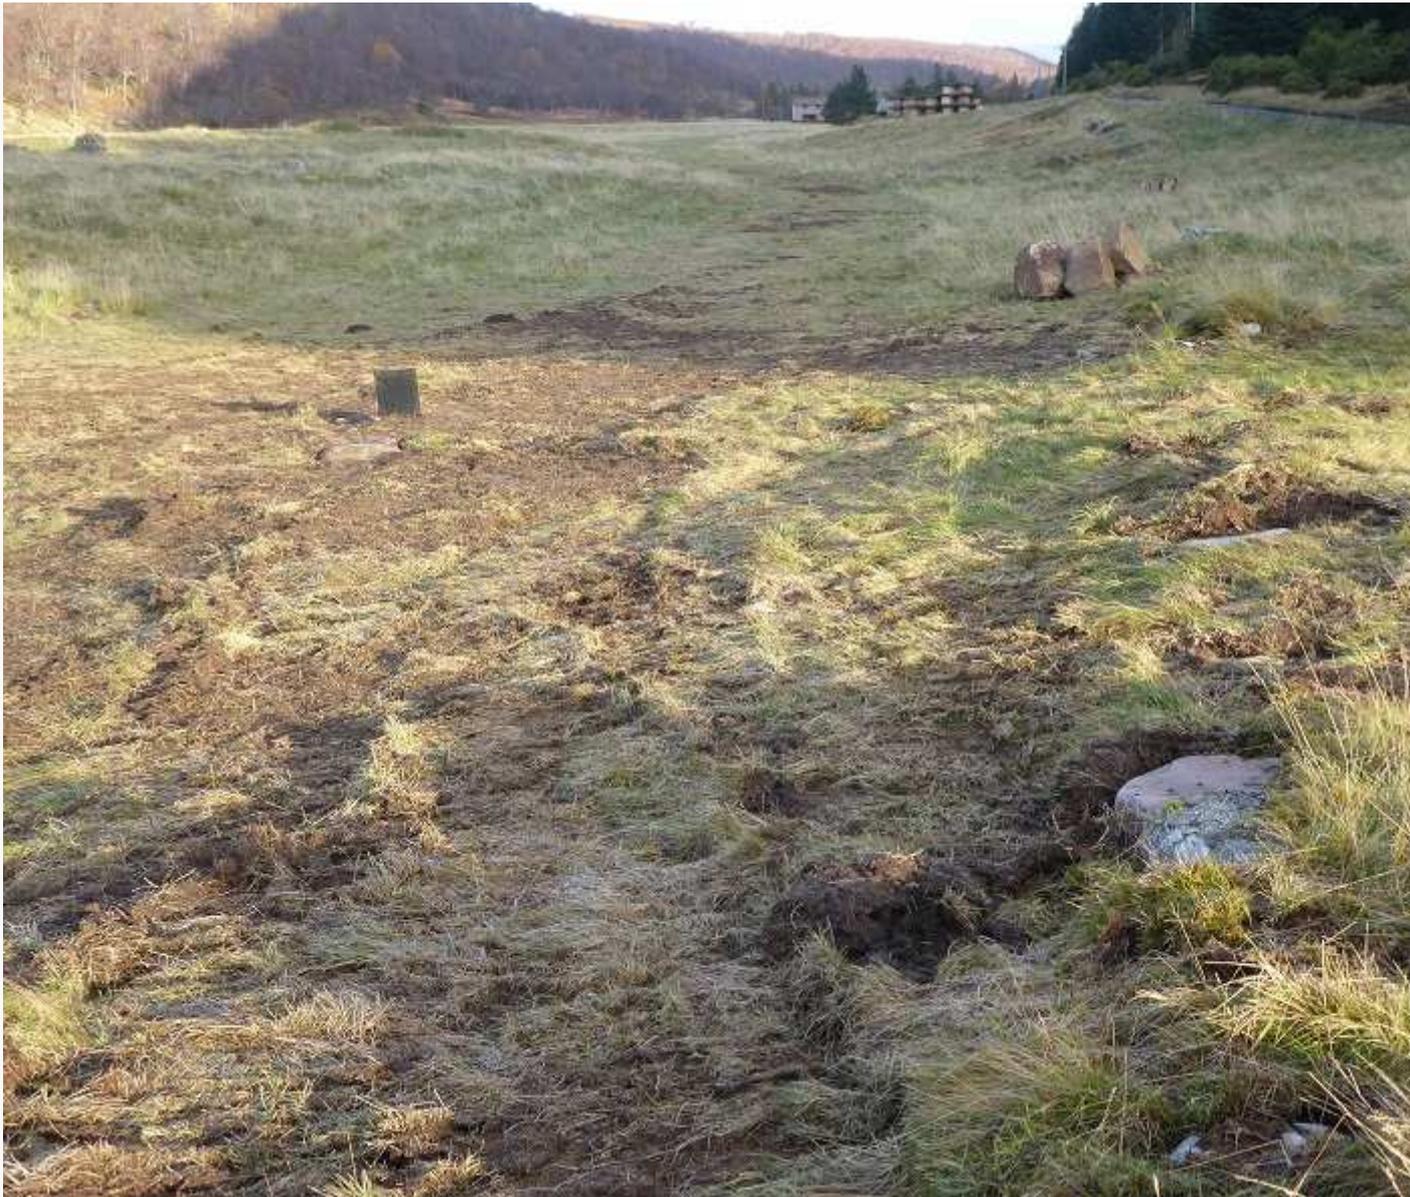
You can however see some evidence that a mole plough has been used. In places boulders have been excavated to allow the passage of the plough and cable.

Apart from the removal of boulders, the vegetation has been little disturbed and on the grassy floor of the glen should recover from the passage of vehicles very quickly. I suspect by next summer, when the grass has had time to grow again, it will be very hard to detect the line of the buried cable.

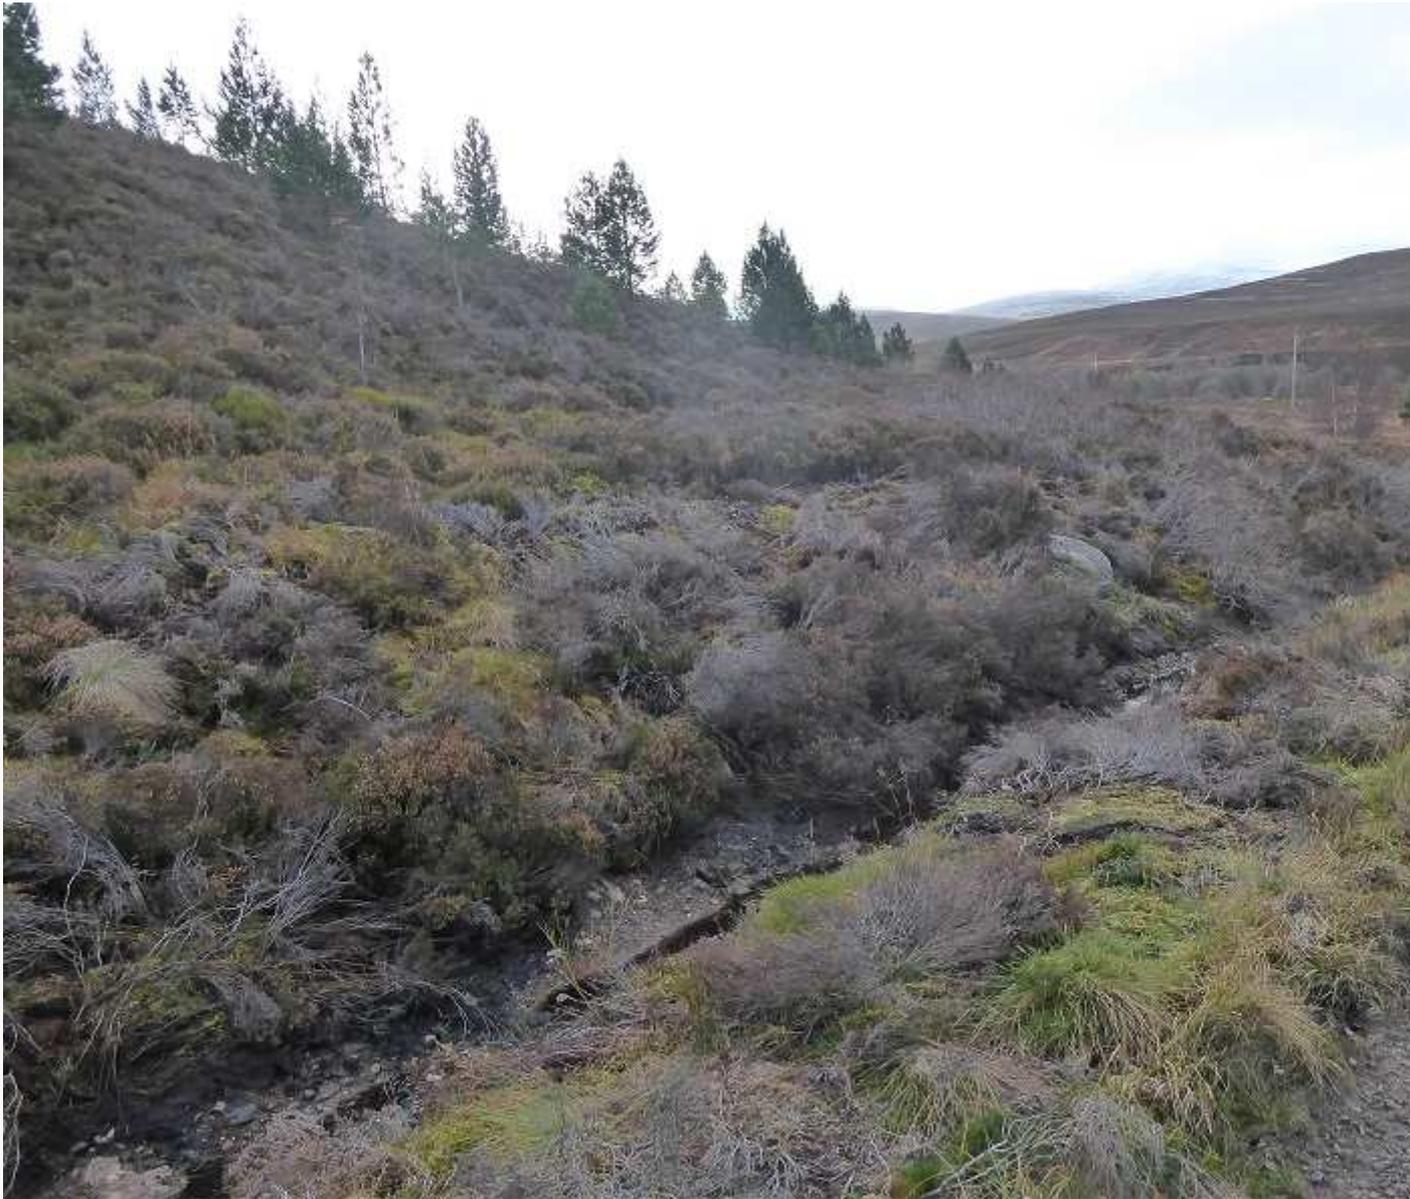
The buried cable is under the disturbed heather on the left side of the road

I was most impressed that the mole plough could also be used on heather moorland and cause so little destruction to vegetation. Again, I think the vegetation here should more or less fully recover in a season.

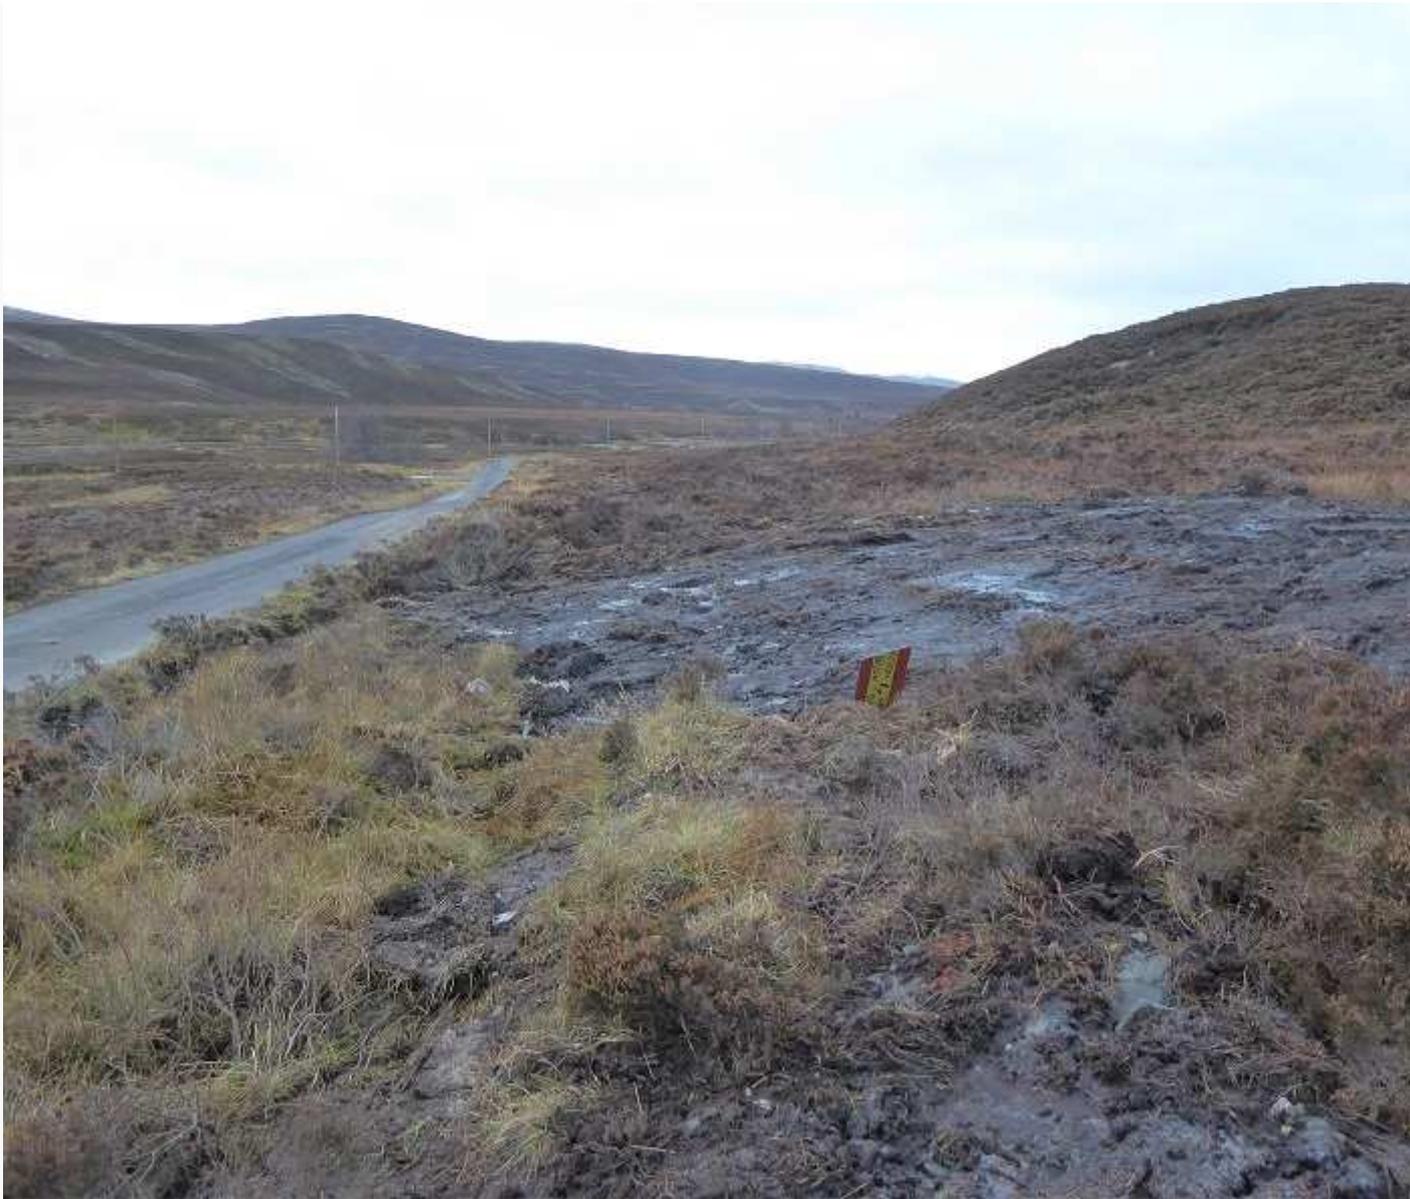
The worst area of ground disturbance/destruction of vegetation on moorland

I then came across the patch of very disturbed ground in the photo above. I was unable to ascertain the cause of this – it may have been a consequence of the land being very boggy – but in the context of several kilometres of buried cable it just served to illustrate in general how well the work had been done and the potential of using mole ploughs.

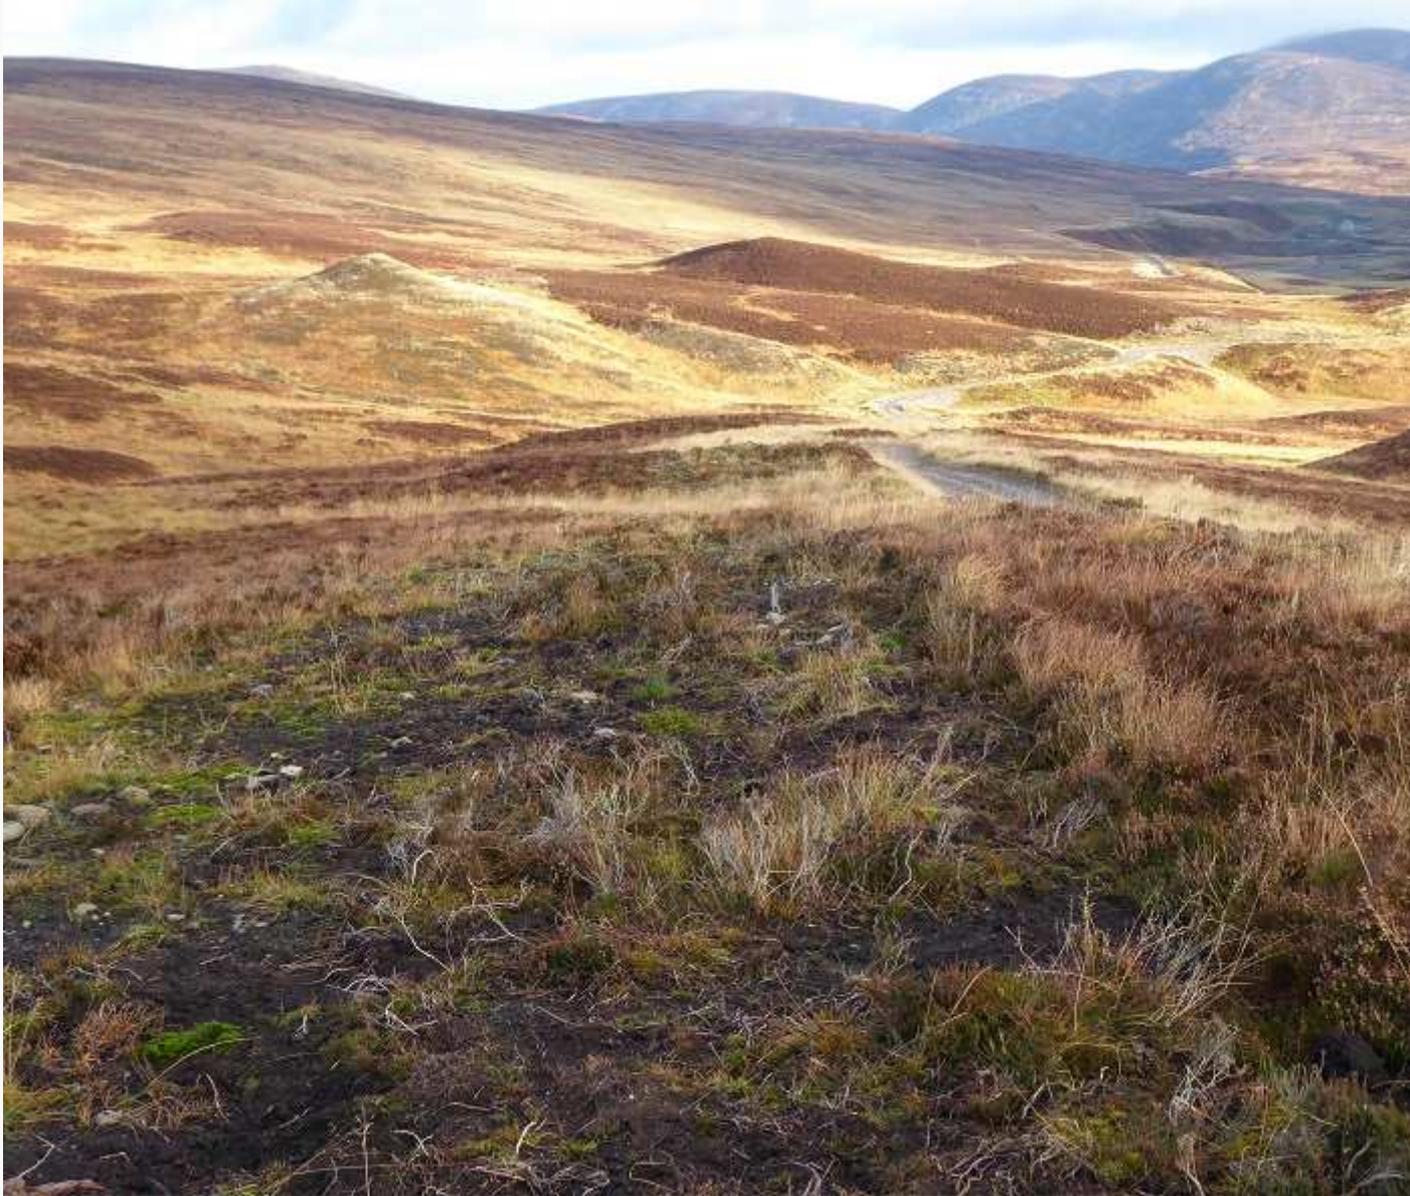
The line of the Glen Bruar power cable runs along the line of disturbed vegetation on the left of the road to the powerhouse which you can just see top right

The advantages of using the mole plough can be seen by comparing the powerline burial in Glen Tromie with that to the new Glen Bruar scheme. While parkswatch has given extensive coverage to the Glen Bruar pipeline restoration above the powerhouse, below it several miles of new electric cable was required to connect it to the grid. The work for this was generally to a high standard – and hence I have avoided comment – but the methodology used was to excavate a ditch, bury the cable and then refill it. Despite the care taken, over two years on the line of the cable is more visible than that in Glen Tromie two weeks after the work finished. The lesson, I believe, is that burying cable with a mole plough, if done well, does significantly less damage than any methods that involves removing vegetation, excavating a ditch and then trying to restore this work.

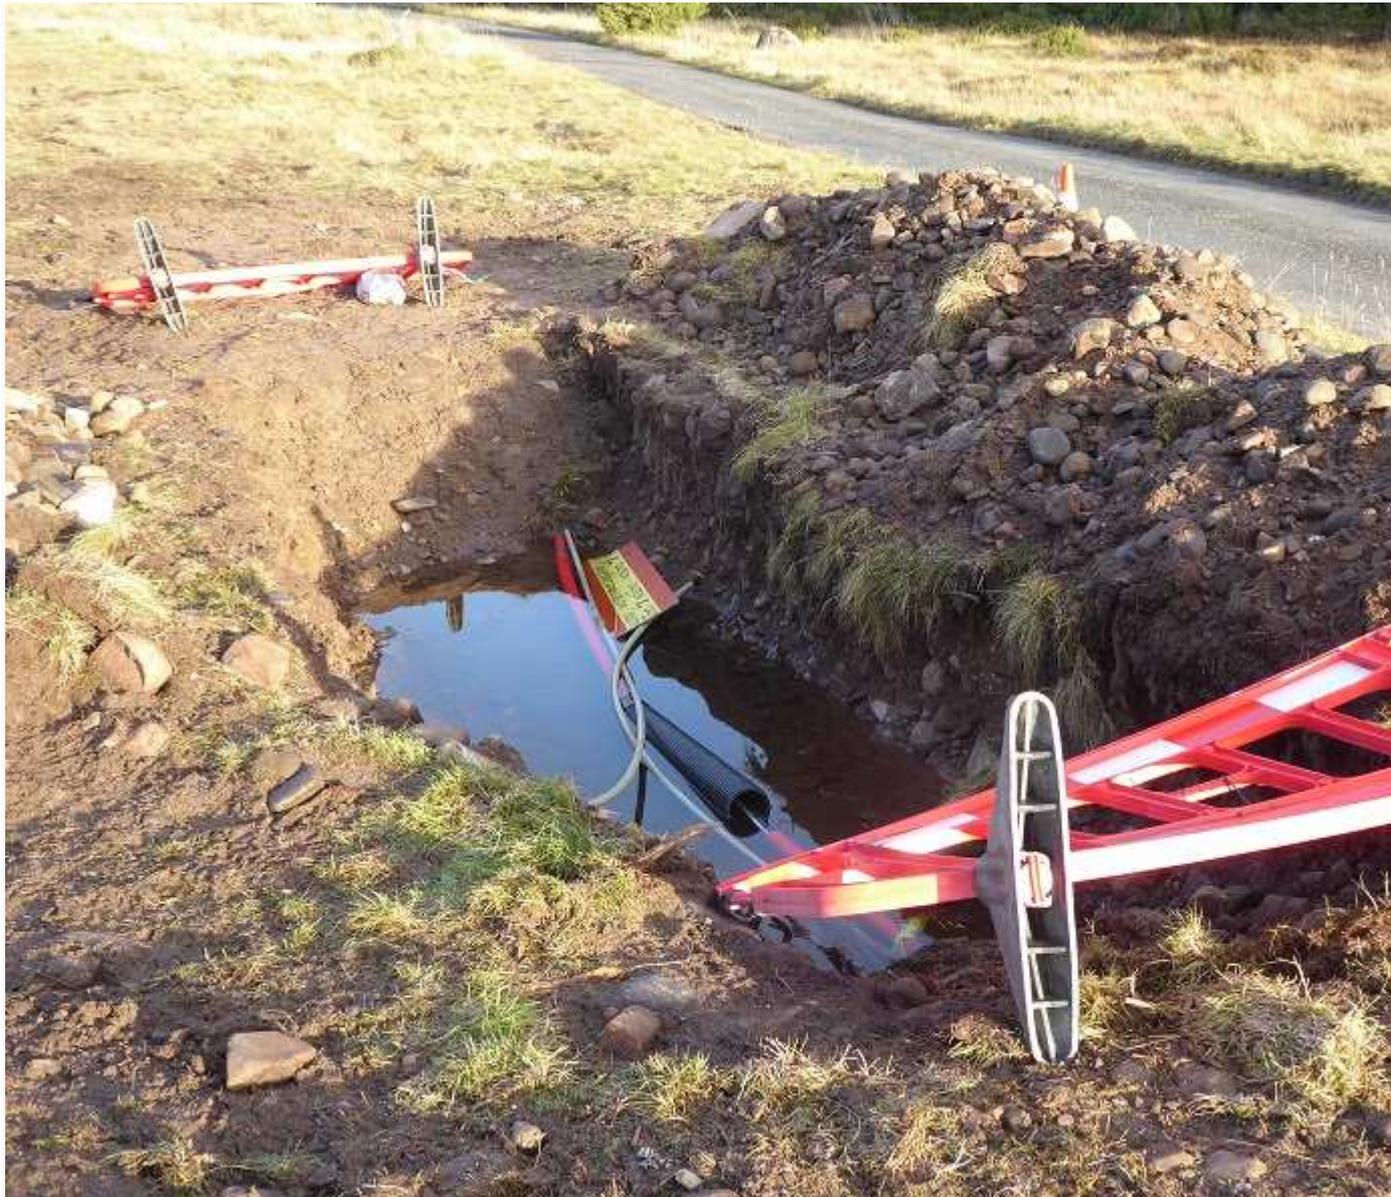
I had seen one example of excavation in Glen Feshie – the hole appeared for connection purposes. It is very difficult – and incidentally far more labour intensive – to restore the ground caused by such digging. Compare this to the impact and work involved in using a mole plough. Thomas MacDonell told us, if my memory is correct, that it had taken just five days to bury the cable in Glen Tromie and, from I saw, very little further work or monitoring will be

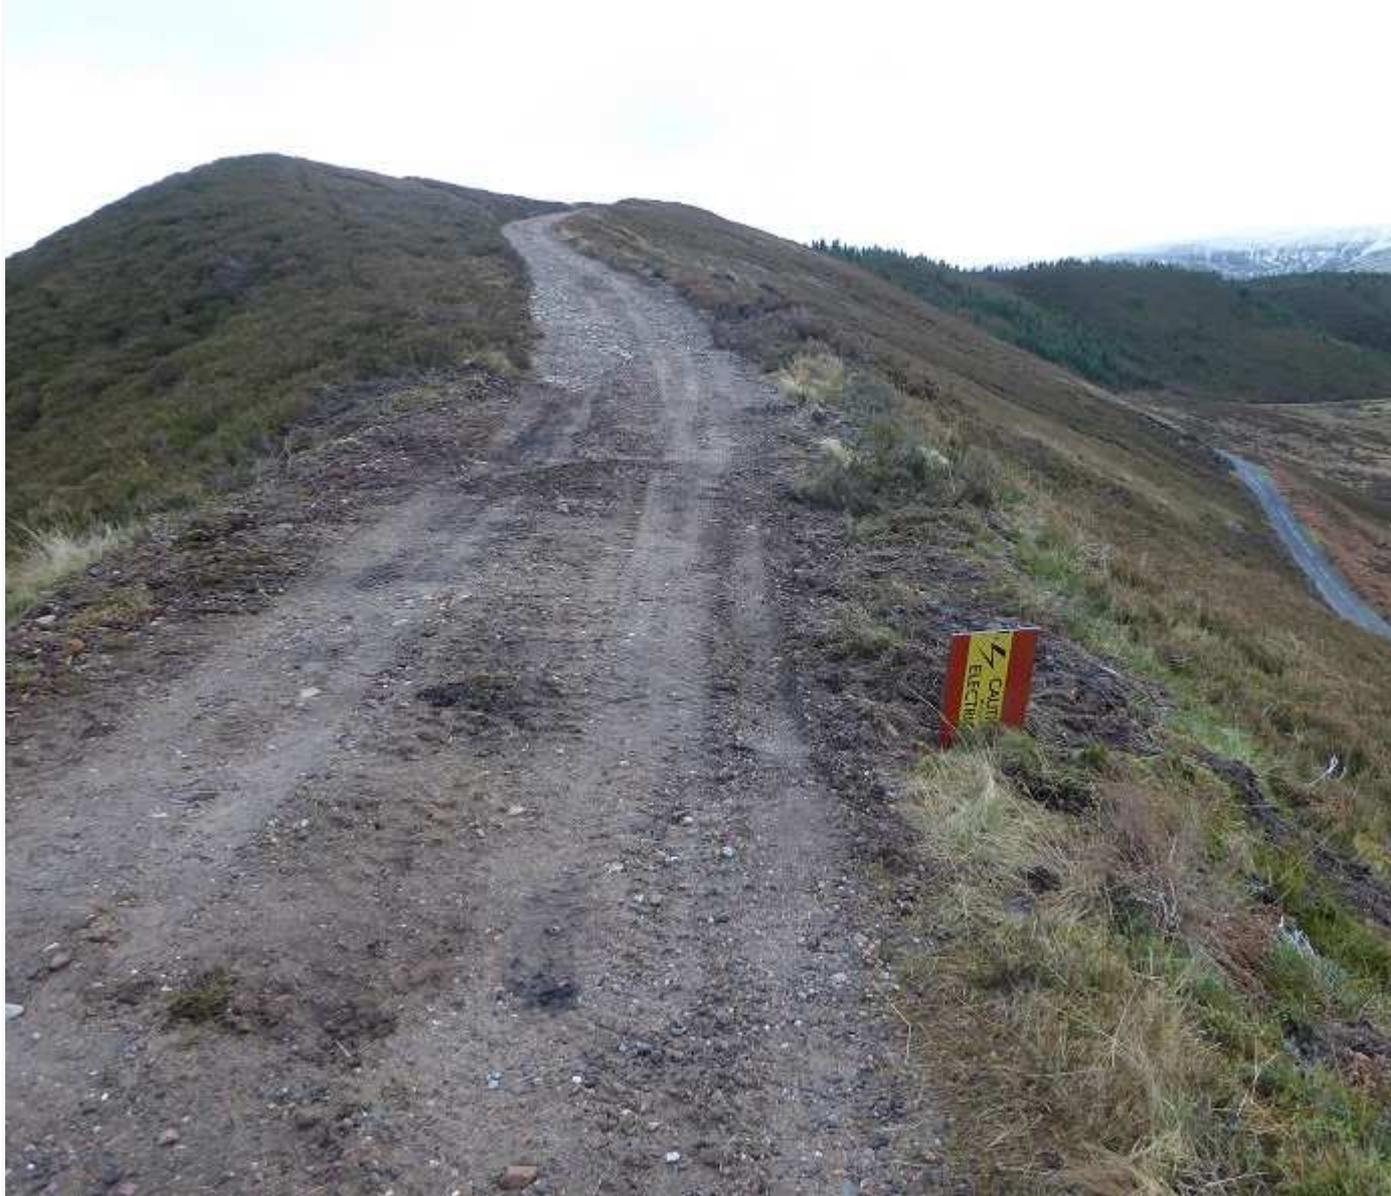
Sign marking where cable crosses the track leading up to the upper Allt Bhran hydro intake – the track below the moraine leads to the Gaick
